# Gearbox Operations Playbook

The American Clean Power Association (ACP)'s Drivetrain Working Group developed the ACP Gearbox Operations Playbook, with the intent to provide guidance for day to day operations of wind turbine gearboxes. Common troubleshooting scenarios and solutions will be discussed. The Drivetrain Working Group represents decades worth of expertise and experience, gained from both wind and other industry sectors. The group's objective is to inform, train and support wind industry technicians, engineers and managers in their efforts to improve reliability and project performance.

The information in this document provides high level guidelines for failure mode identification, maintenance, monitoring, and inspection of wind turbine gearboxes. Common troubleshooting scenarios and solutions to those scenarios will be addressed. These contents will best support those who are being introduced to the wind industry or the operation of wind turbine drivetrains.

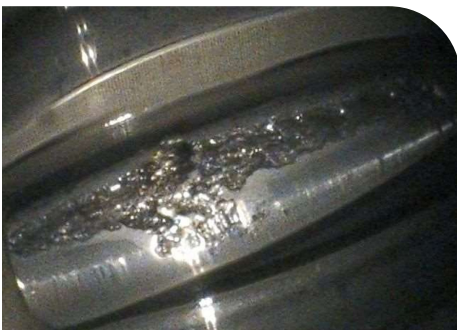
This failure mode is initiated by stress concentrations caused by existing surface defects. Progressed macro pitting can sometimes initiate spalling. Spalling can vary in size and depth, but once this failure mode has initiated the replacement of the gear will need to be prioritized.

Figure 10: Spalling damage initiated from surface damage at the dedendum of a gear tooth.

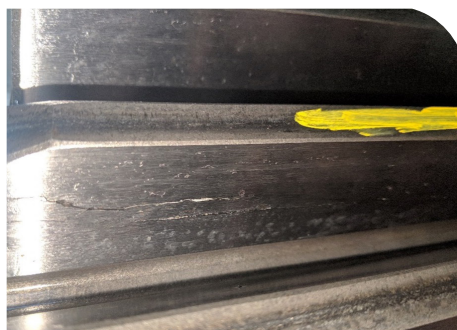
Cracks are visible separation of material within itself. Cracks will lead to full fracture of the tooth, but in some cases, if caught early enough, the tooth may still be found intact. This is optimal to find the cause of the failure. If a crack is found, the gear will eventually need to be replaced.

Figure 11: Example of a cracked tooth that is still intact

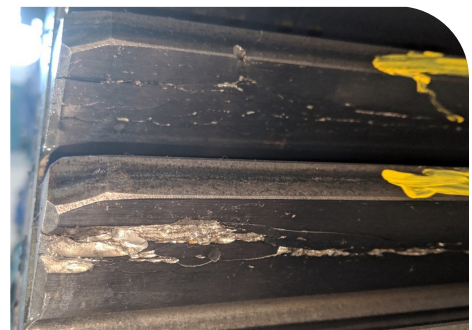
Figure 12: Example of two cracked teeth, one has progressed enough to remove areas of the surface material, the other is not as progressed.

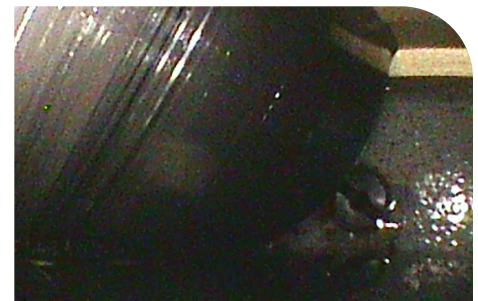
These lines are caused by small debris particles temporarily lodging in one spot (Ex: between a cage and roller). The debris will wear off a very small portion of the roller's surface. Typically, these are seen more on bearings with coating, as the coatings can wear off more easily than the actual surface of the roller. Most of these lines have little or no depth to them, as they are polished surfaces. As with false Brinell marks, if these lines do not form pitting, the bearing is fine for continued operation.

Figure 18: Bearing roller with typical radial running lines

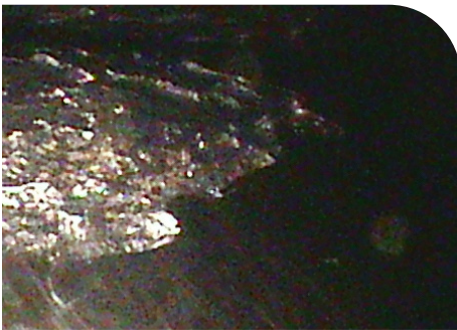
Spalling in bearings can be initiated by both surface and subsurface defects. Spalling in bearings, like in gearing, can be the result of the coalition of macro pits. This failure mode can have various shapes and depth, but in every case, once a bearing has spalled the failure mode will progress. A replacement plan for the damaged bearing should be put in place and prioritized based on the level of progression.

Figure 24: Bearing race with severe spalling

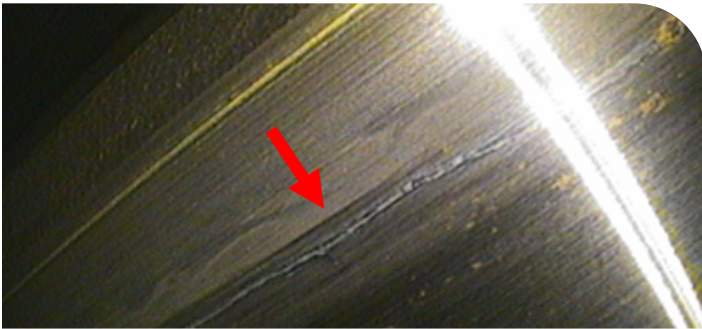
Figure 30: Scratch on gear tooth

The image on the below left (Figure 30) shows a scratch on the gear tooth. The image on the below right (Figure 31) demonstrates the shiny result of micro pitting along a grinding asperity. Both were mis-diagnosed as gear tooth cracks.

Borecope inspections are fraught with challenges and capturing a great image is one of the most difficult to overcome. Even if the lens is clean of oil and free from scratches, limited light, focal length, and fisheye images can make identification of the extent of wear or damage, almost impossible for the inexperienced. Unfortunately, “false positives” are not unusual. Below are some real-world examples.
